Manhole Inspection Summary

Manhole # S51O__040MH

Insp Date: **7/28/09 3:46 PM**

Location Address: **1222 S. CURLEY ST**

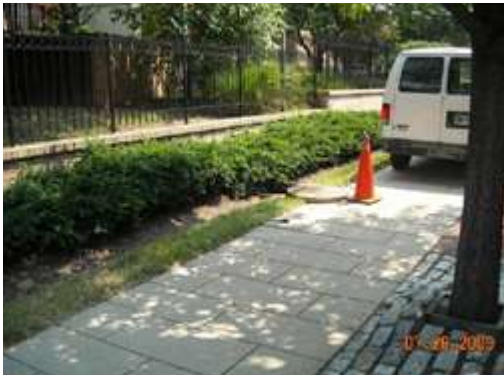
Location View

Comments **LOCATED IN THE GRASS/LANDSCAPED AREA; FORCED OPEN COVER WITH 16LB MAUL**

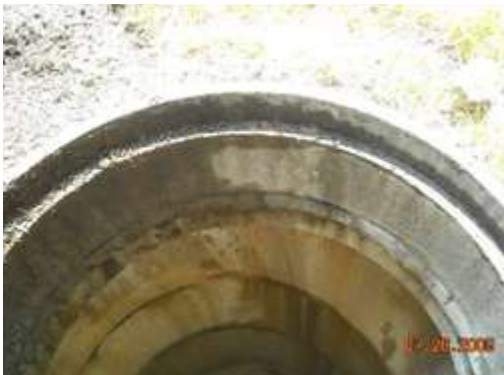
Defect 1

☒ **Leaks**

FRAME LEAKS

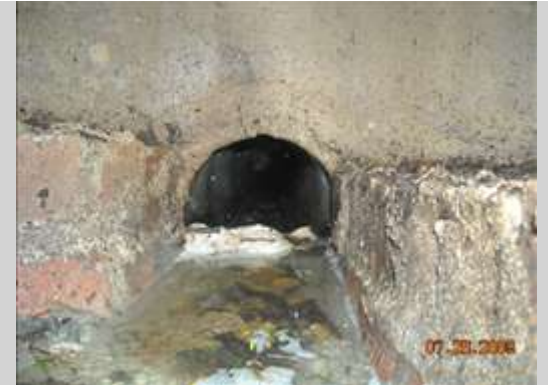
12 O'Clock Outflow

8 in. Circular Gravity Sewer
Pipe Out @ 12 O'Clock

Pipe Height: **8.4** (in.) Rod and Bar (Angled)
Pipe Material: **Clay** ☐ Pipe Lined
Invert Depth: **11.40** (ft.) Flow Characteristics: **Slow**
Deposits: ☒ None ☐ Mud ☐ Sludge ☐ Debris ☐ Grease
Silt Depth: **0** (in.) Deposits Extent:
Infiltration: **None** Pipe Seal Cond: **Sound**

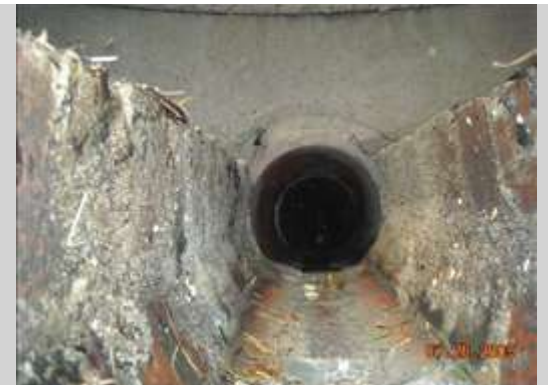
6 O'Clock Inflow

8 in. Circular Gravity Sewer
Pipe In @ 6 O'Clock

Pipe Height: **8.4** (in.) Rod and Bar (Angled)
Pipe Material: **Clay** ☐ Pipe Lined
Invert Depth: **11.30** (ft.) Flow Characteristics: **Slow**
Deposits: ☒ None ☐ Mud ☐ Sludge ☐ Debris ☐ Grease
Silt Depth: **0** (in.) Deposits Extent:
Infiltration: **None** Pipe Seal Cond: **Sound**

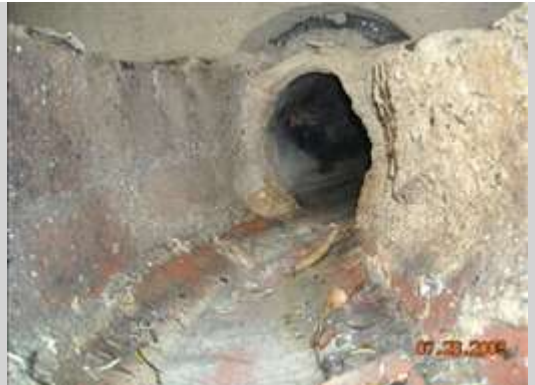
9 O'Clock Inflow

8 in. Circular Gravity Sewer

Pipe In @ 9 O'Clock

Infiltration: **None** Pipe Seal Cond: **Sound**
